PIUMA TWIN - builder and pilot Luca Baldi – First fly december 20th 2008

Report of checks carried out after the crash, compiled by Tiziano Danieli, planner of the Piuma Twin with “T” elevator, on the airfield at the time of the accident and came to the rescue with the friends present after a few minutes from the impact, from which the builder and 'unharmred, despite the rollover on the plowed ground.

TECHNICAL REPORT

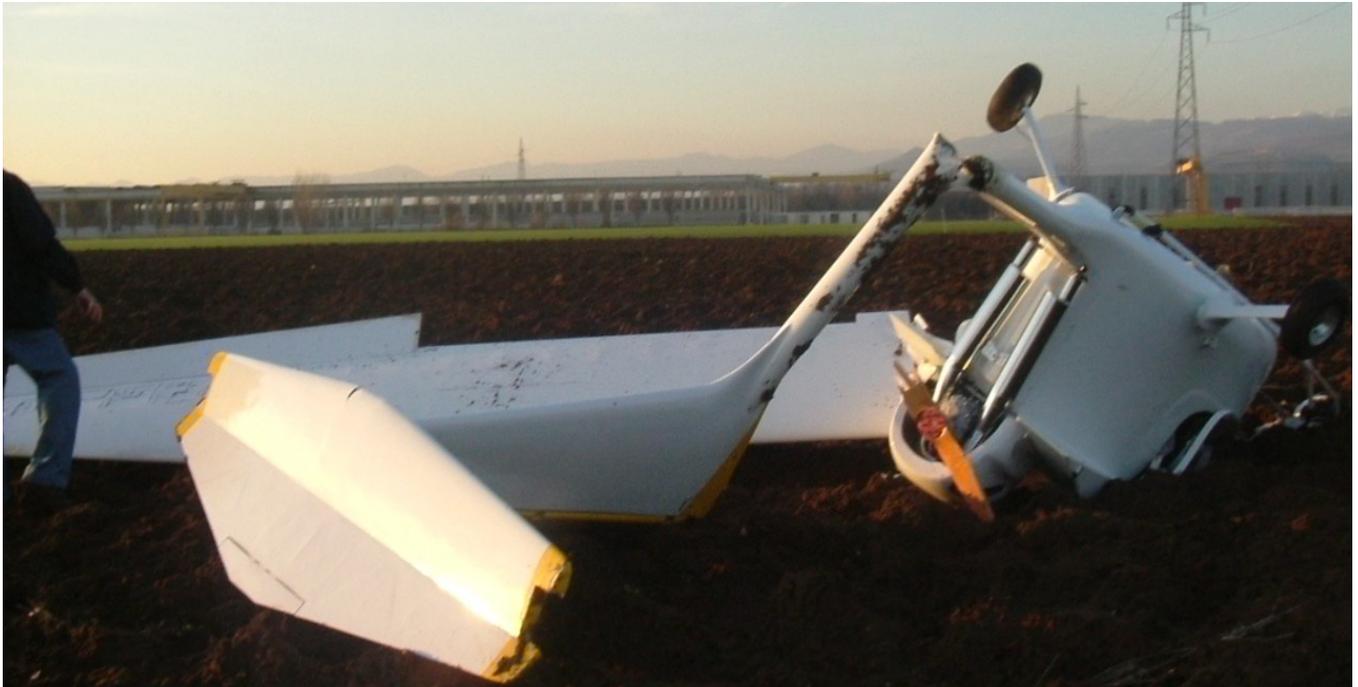
The seat area and the area of the fuselage under the wings remain virtually intact (see photo) and the pilot comes out of the cockpit only partially reversed through the canopy of Plexiglas that broke on impact; you do not have neither fuel leakage, or principles of fire and the engine remains intact having only touched the ground, protected by the fairing.

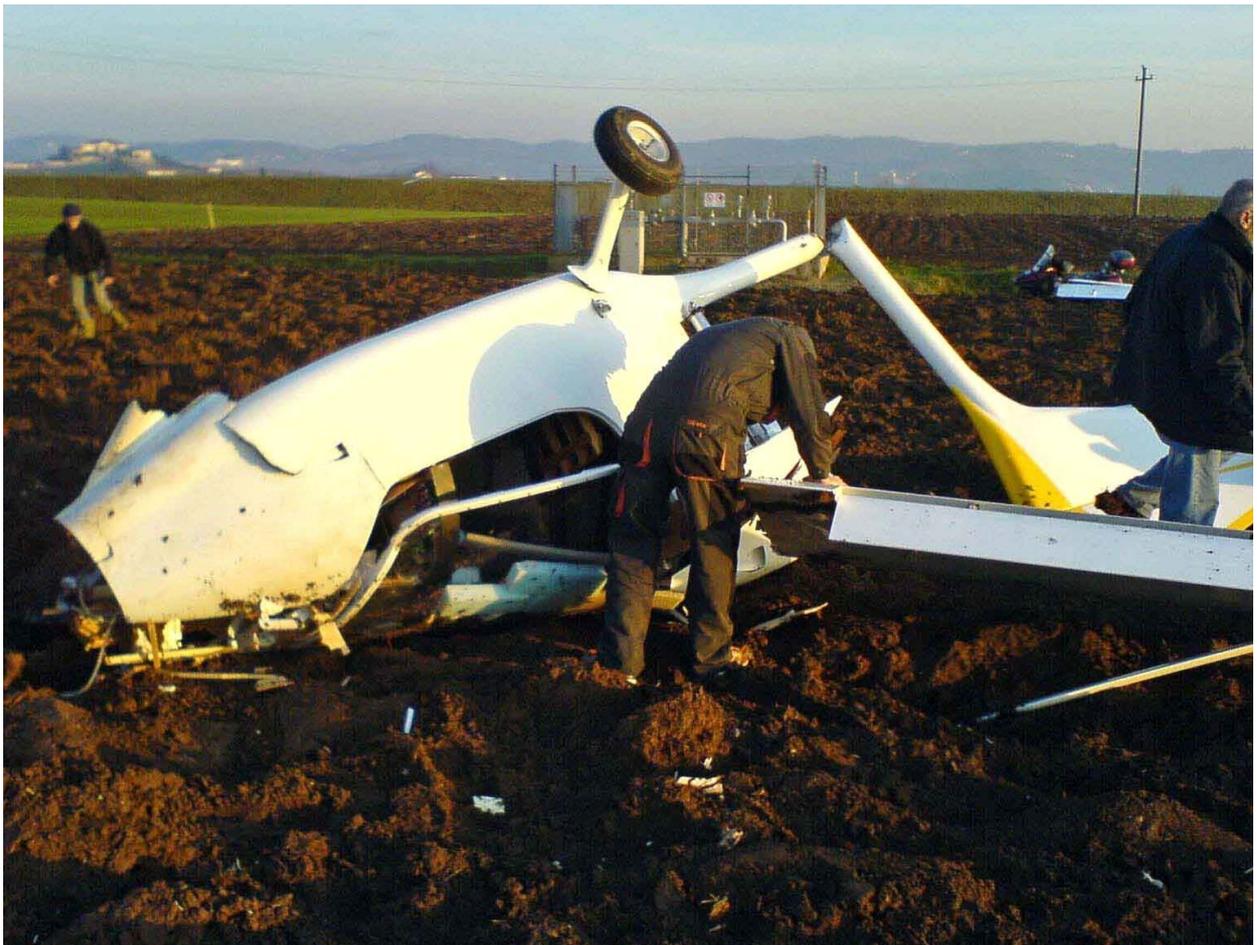
4) Omission of a structural reinforcement: Another serious shortcoming detected was the omission of a structural reinforcement project on the part of the vertical plane which is fixed before the tailplane (see drawing and photo); rupture in flight of the weaker party could have triggered the oscillations.

The attack was the front folded and detached in his right side and then raised and attached asymmetrically only on the left side (see photo); the rupture could have occurred during the overthrow at impact, but could also have occurred in flight due to strong turbulence propeller strongly misfit; lifting and tilting of the resulting tailplane may have triggered the oscillations; when the rupture occurred was impossible to tell.
